SPC 3.13.5

FIRMWARE RELEASE NOTES

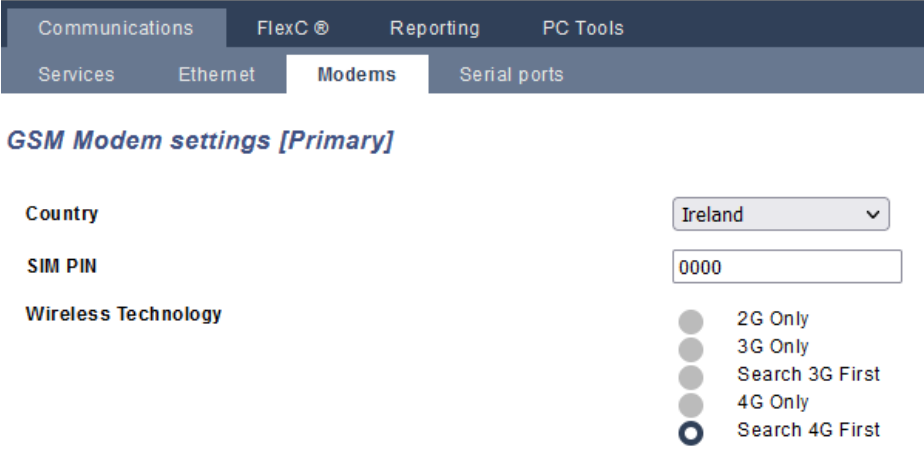
Feature Description	Adding additional modem configuration options and signal strength monitoring.
Interface Changes	<p>Modem configuration webpage displays the new 4G modem network mode list: Provide support for 4G, 3G and 2G network Add new configuration options to select priority of the network selection</p>

<p>The screenshot shows a navigation menu with 'Modems' selected. Below it, the 'GSM Modem settings [Primary]' section includes a 'Country' dropdown set to 'Ireland', a 'SIM PIN' input field with '0000', and a 'Wireless Technology' section with radio buttons for '2G Only', '3G Only', 'Search 3G First', '4G Only', and 'Search 4G First' (which is selected).</p>

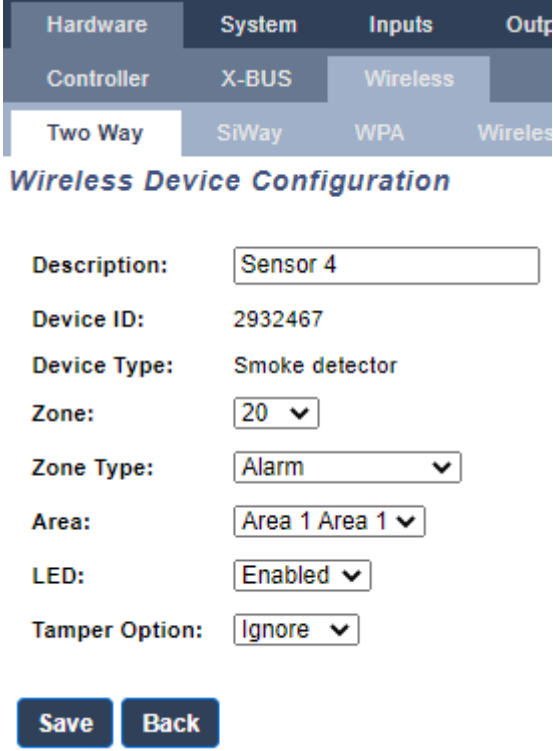
<p>Feature/Bug Description</p>	<p>Smoke detectors SW v0.2.0.3 and higher support having their LED enabled/disabled and their supervision time set to 1/2/4/7/10/15/20/30 minutes as long as they are communicating via a 4.7 transceiver. This is now supported: the LED configuration will appear and affect these smoke detectors and changing the supervision will affect their supervision time.</p>
<p>Interface Changes</p>	<p>Smoke detector configuration web page displays:</p>

<p>The screenshot shows a navigation menu with 'System' selected. Under 'System', 'Wireless' is selected. Under 'Wireless', 'WPA' is selected. The main content area is titled 'Wireless Device Configuration' and contains the following fields:</p> <ul style="list-style-type: none"> Description: <input type="text" value="Sensor 4"/> Device ID: 2932467 Device Type: Smoke detector Zone: <input type="text" value="20"/> Zone Type: <input type="text" value="Alarm"/> Area: <input type="text" value="Area 1 Area 1"/> LED: <input type="text" value="Enabled"/> Tamper Option: <input type="text" value="Ignore"/> <p>At the bottom, there are 'Save' and 'Back' buttons.</p>
